## Spray Foam Insulation and Subterranean Termite Inspection Issues - April 2021

The Georgia Structural Pest Control Commission (GASPPC) appreciates the opportunity to provide the Energy, Residential and Building Amendments Subcommittee, additional information pertaining to our proposed building code changes.

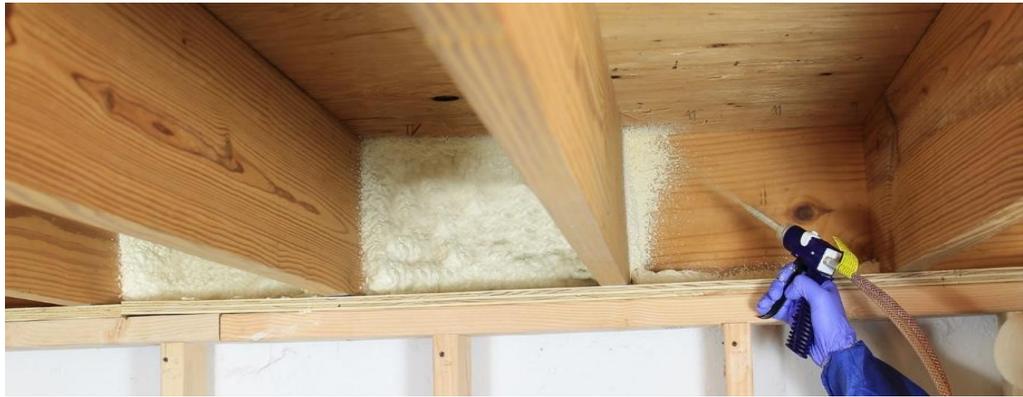
Termites will use spray foam as a bridge to bypass mechanical obstacles and treated wood to gain access to untreated wood in a structure.

Spray foam hides, provides protection, and enables termites to move undetected to find and exploit food sources.

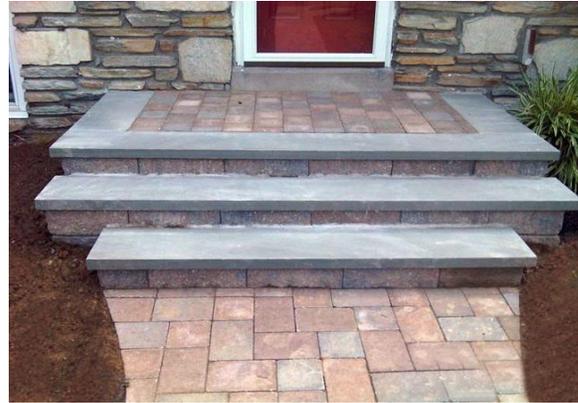
In the picture to the right, you can see that the termite shield extends over the **inside** and outside of the foundation wall. You can also see that the **outside** foundation wall will be completely hidden behind added brick or stone veneer sitting on the ledge below (arrow), providing hidden access for termite entry on the exterior foundation walls. In this situation, SPF's proposal would allow the FFI to be covered with spray foam and the homeowner will pay the price of having an invisible infestation persist for years before detection.

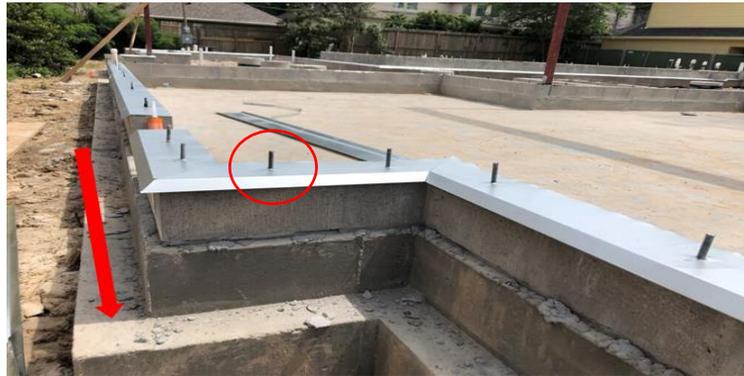
There are many ways to secure the sill plate to the foundation. The picture **above** shows anchor bolts (circled) being used to secure the sill plate to the foundation. The bolts must pass through a termite shield creating the need to seal each bolt. In this situation, given that even a 1/64<sup>th</sup> inch gap would compromise the "shield". The attention required as to the details of a sealing application and maintaining the integrity of the "shield" are obvious reasons why this methodology is no longer recommended after decades of less-than-satisfactory experience.

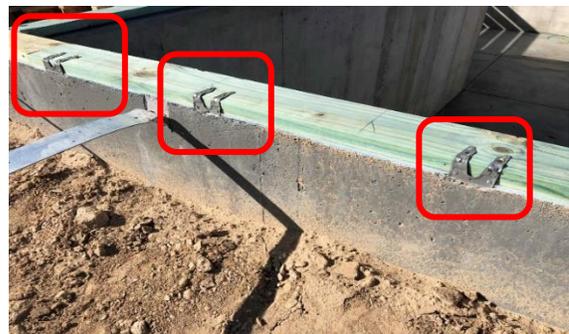
As I mentioned the sill plate can also be secured to the foundation by using a variety of types of foundation straps. The picture to the right shows one type of sill plate straps / anchors in use, yet there are many varieties and designs in the marketplace. These straps / anchors are imbedded into the foundation making it extremely difficult, if not impossible to install a termite shield and be able to seal it as required around each strap.

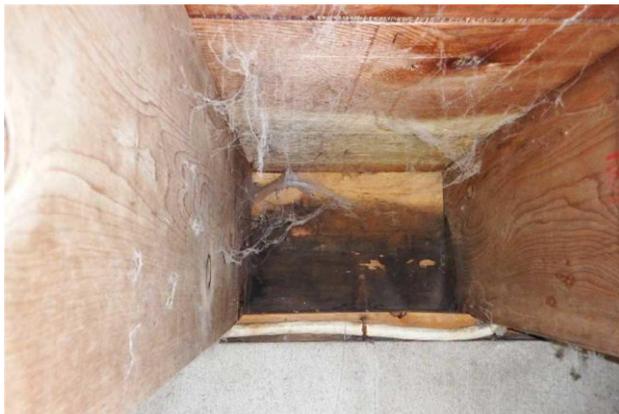
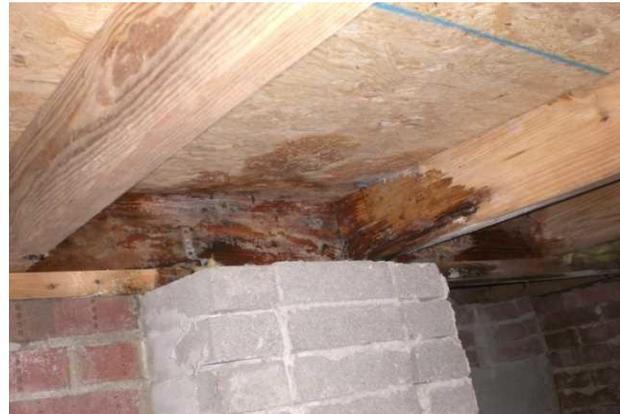
In the two pictures below, you can see common moisture situations that occur at the FFI when drainage on the exterior of the home is not moving water way from the structure.

Moisture has been continuously stated by SPF proponents as a major concern with the GASPPC proposal, but they have provided no information on how SPF interacts with moisture. The same properties that permit SPF to exclude moisture from external sources, would hold moisture against wood components if there is a leak or faulty construction, consistent with the problems identified with a similar product and problem in the 90's, "Rigid Board Insulation or DRYVIT". This has already been experienced, as the UGA SPF Demonstration Project showed higher wood moisture content in wood that was behind or under spray foam after the foam was removed. Wood decay fungus grows and damages wood when the wood moisture exceeds 22%.

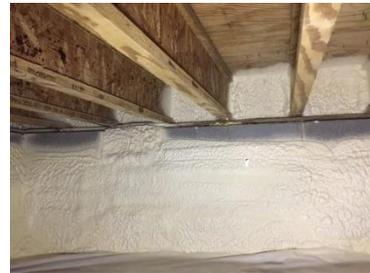
SPF proponents also continue to put forward a narrative about termites ***“posing significant concerns with or without spray foam and inspections for termites being only 33% effective because of hidden pathways that exist in structure”***. The pest management industry fully understands the limitations we have with the amount of a structure that is visible, but unlike SPF proponents the pest management industry continuously adapts and offers consumers in Georgia termite protection with highly effective treatments and inspections by skilled, knowledgeable and state licensed individuals. In addition, homeowners are protected by licensed and regulated pest management companies who offer warranties on the work provided, and protection against future infestations. SPF proponent's narrative on the state of the pest management industry is disingenuous and misinformed as they propose to cover, without assuming any responsibility, the ***most important area*** for WDO inspections afforded within a structure, the framing foundation interface.
